# New York State Department of Transportation

## PIA Safety Flag NB2358W010

**BIN: 1065318**

Feature Crossed: 6TH AVENUE

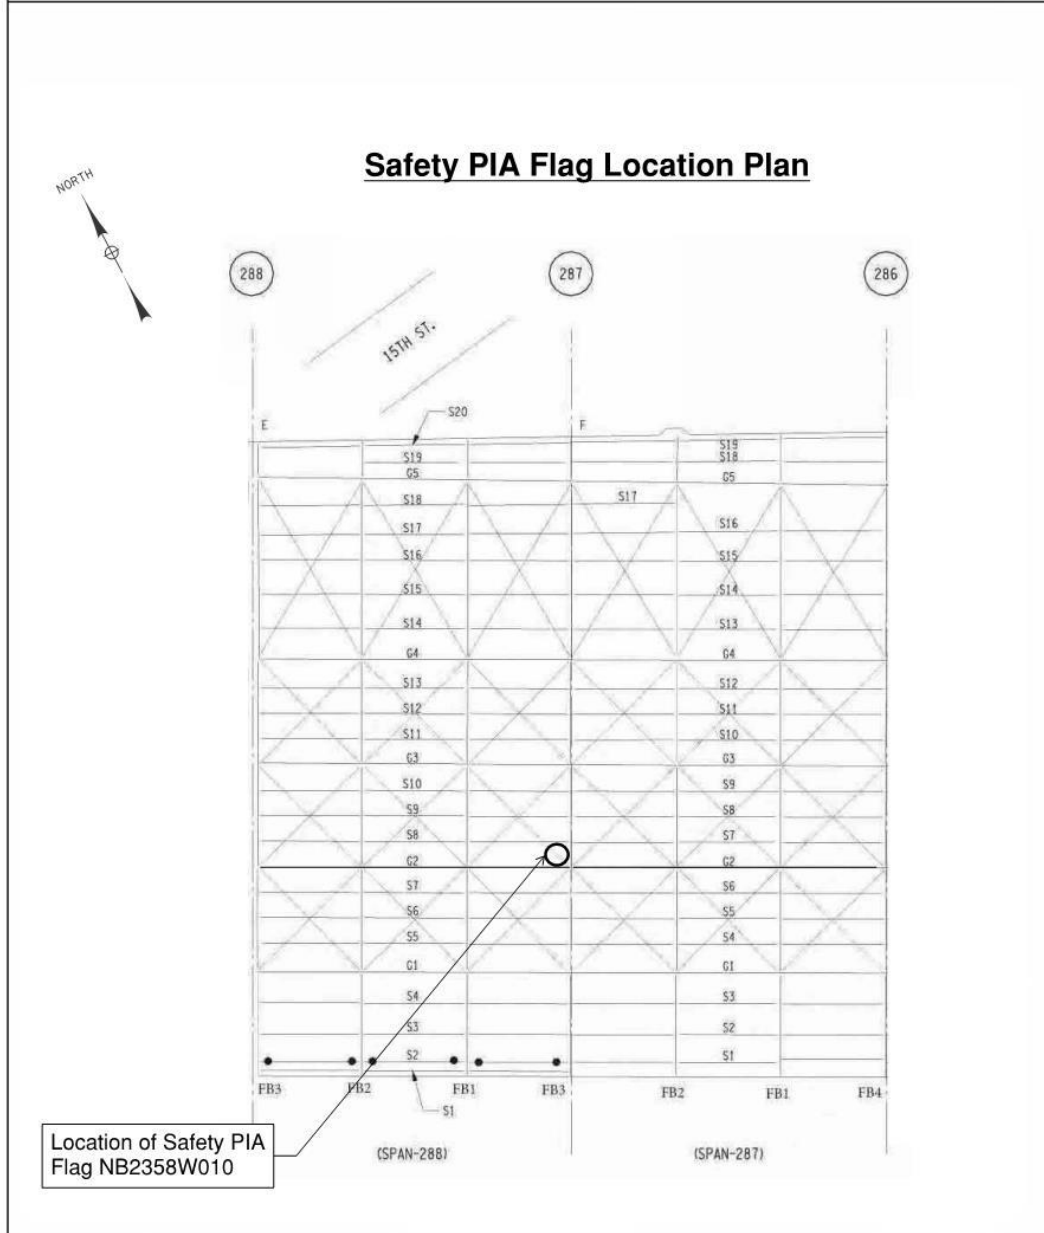
**Flag Photographs**Photo Number: **1**Photo Filename: **23\_Flag Location Plan.jpg**Gowanus Expressway  
2023 Biennial Inspection - Field SketchBIN: 1065318Team: AA/TSDate: 05/03/2023Span: 288Location: Lateral Bracing btwn G2-G3 at Pier 287

Location: Span 288, Lateral Cross Bracing between Girders G2-G3 adjacent to the right side of G2 at Pier 287 above the left shoulder on the exit street from Hamilton Ave. EB roadway to Hamilton Ave. WB roadway.

**wsp****Attachment Description: Flag Location Plan**

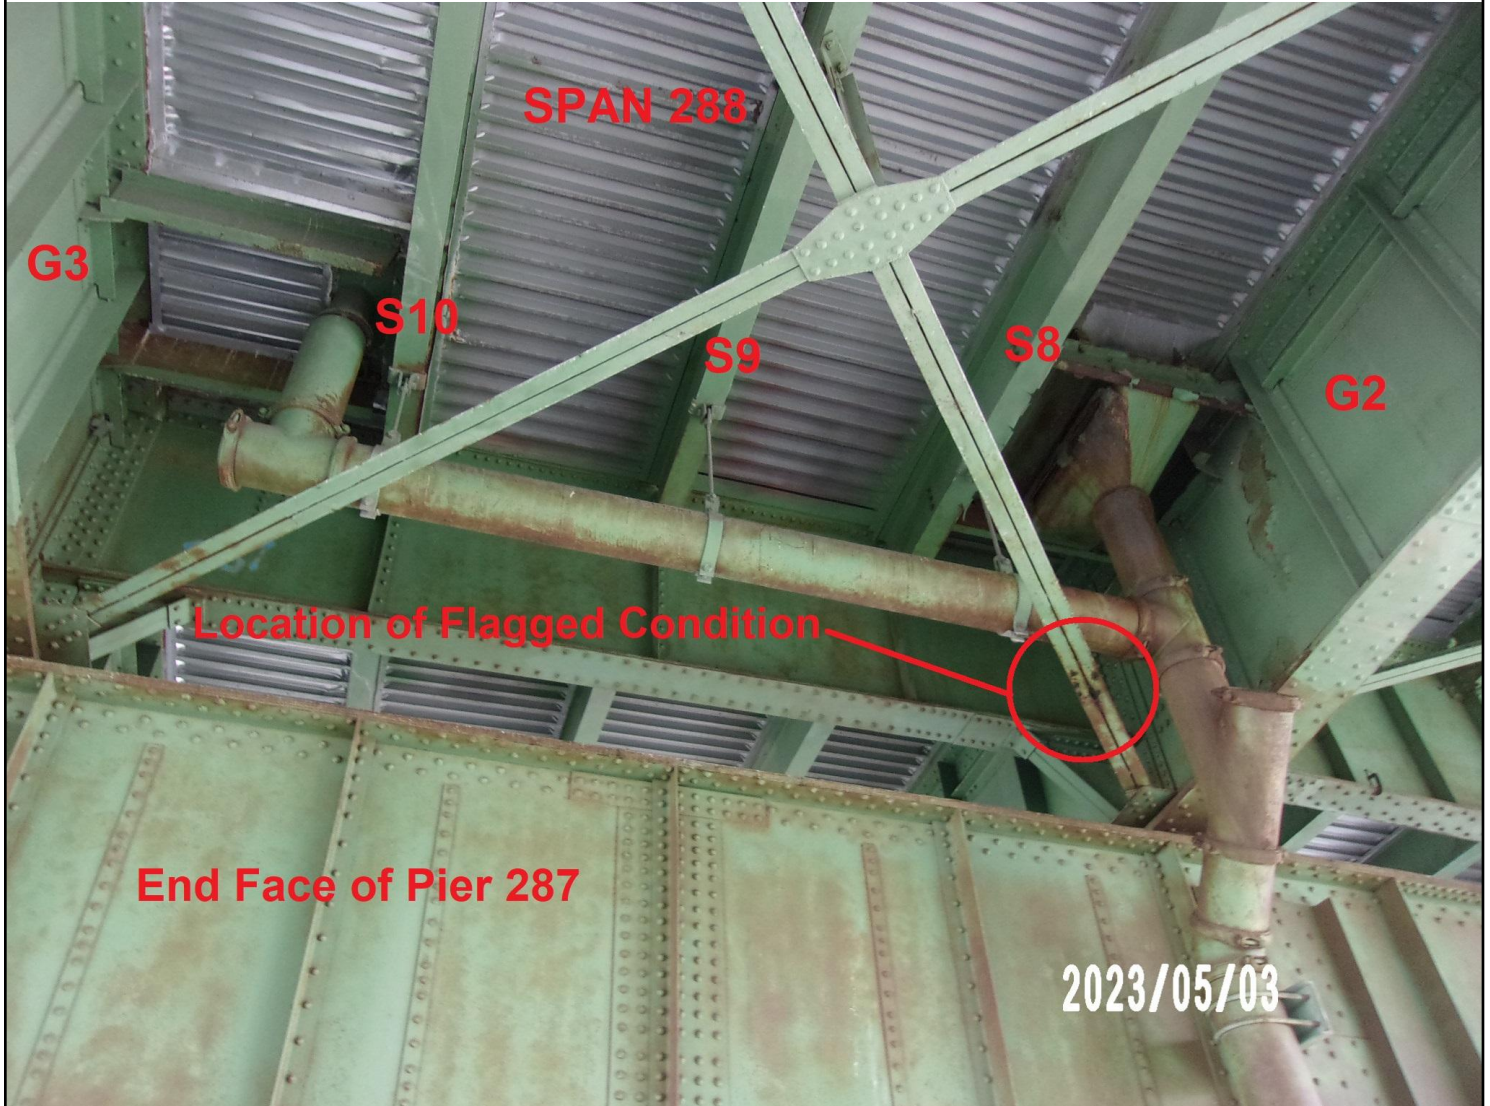
Photo Number: 2

The deteriorated area at the cross bracing is located above the left shoulder on the exit street from Hamilton Ave. EB roadway to Hamilton Ave. WB roadway. The safety concern would be the unbraced portions of the cross bracing legs falling onto the vehicular and pedestrian traffic below.

**Attachment Description:** General view of the flagged condition at the lateral cross bracing at the right side of Girder G2 in Span 288 at Pier 287. Looking Begin.

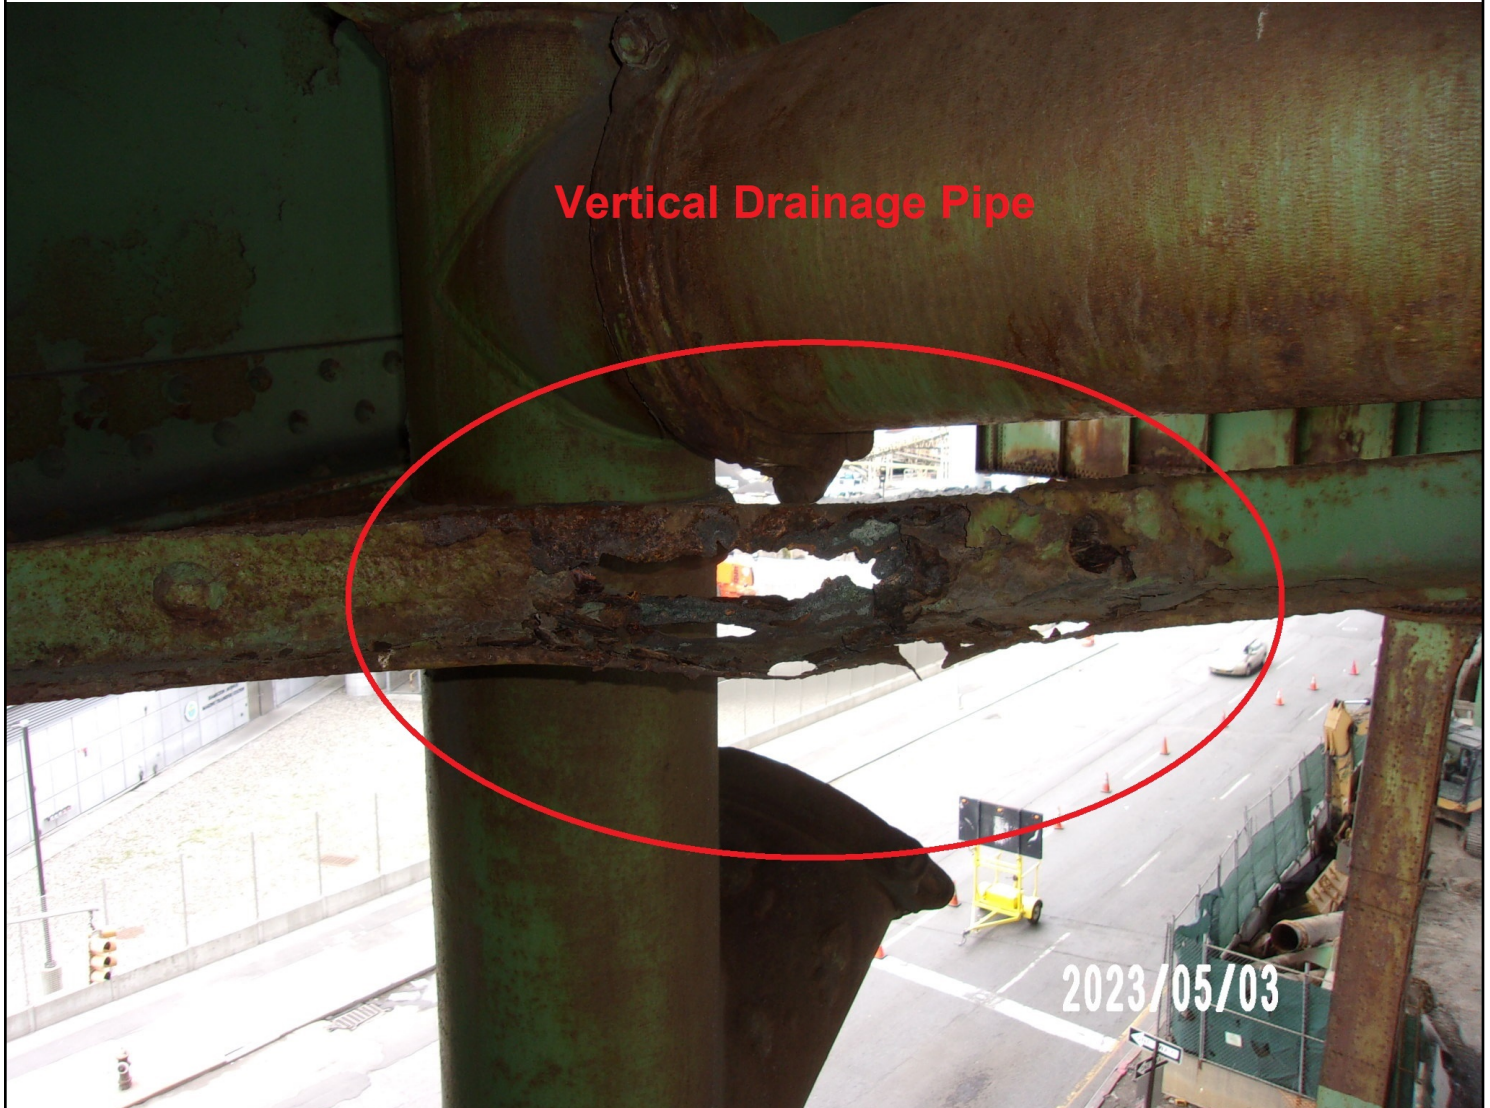
Photo Number: 3

The portion of the lateral cross bracing leg adjacent to the right side of Girder G2 in Span 288 at Pier 287 exhibits heavy corrosion with severe section loss and several corrosion holes for 18" long section approximately 4ft from the connection to Girder G2 (Photo 3). When the inspection team hammered the location, the lateral cross bracing leg on both sides of the deteriorated area deflected downwards. This deteriorated area at the lateral cross bracing still exhibits delaminated steel but the inspection team did not hammer any further due to the risk of the lateral cross bracing leg separating/breaking completely at this location resulting in two portions of the leg which are only supported at one end of each leg.

The lateral bracing between Girders G2 & G3 at Pier 287 at right side of Girder G2 has severe corrosion with section loss and several corrosion holes (3" x 1"; 1.5" x 1"; 2" x 1") over an 18" L section.

**Attachment Description:** The right face of lateral cross bracing between Girders G2-G3 in Span 288 at the right side of G2 at Pier 287. The lateral cross bracing exhibits heavy corrosion with severe section loss and several corrosion holes (circled). The lateral cross bracing still exhibits delaminated steel. Looking End and Left.

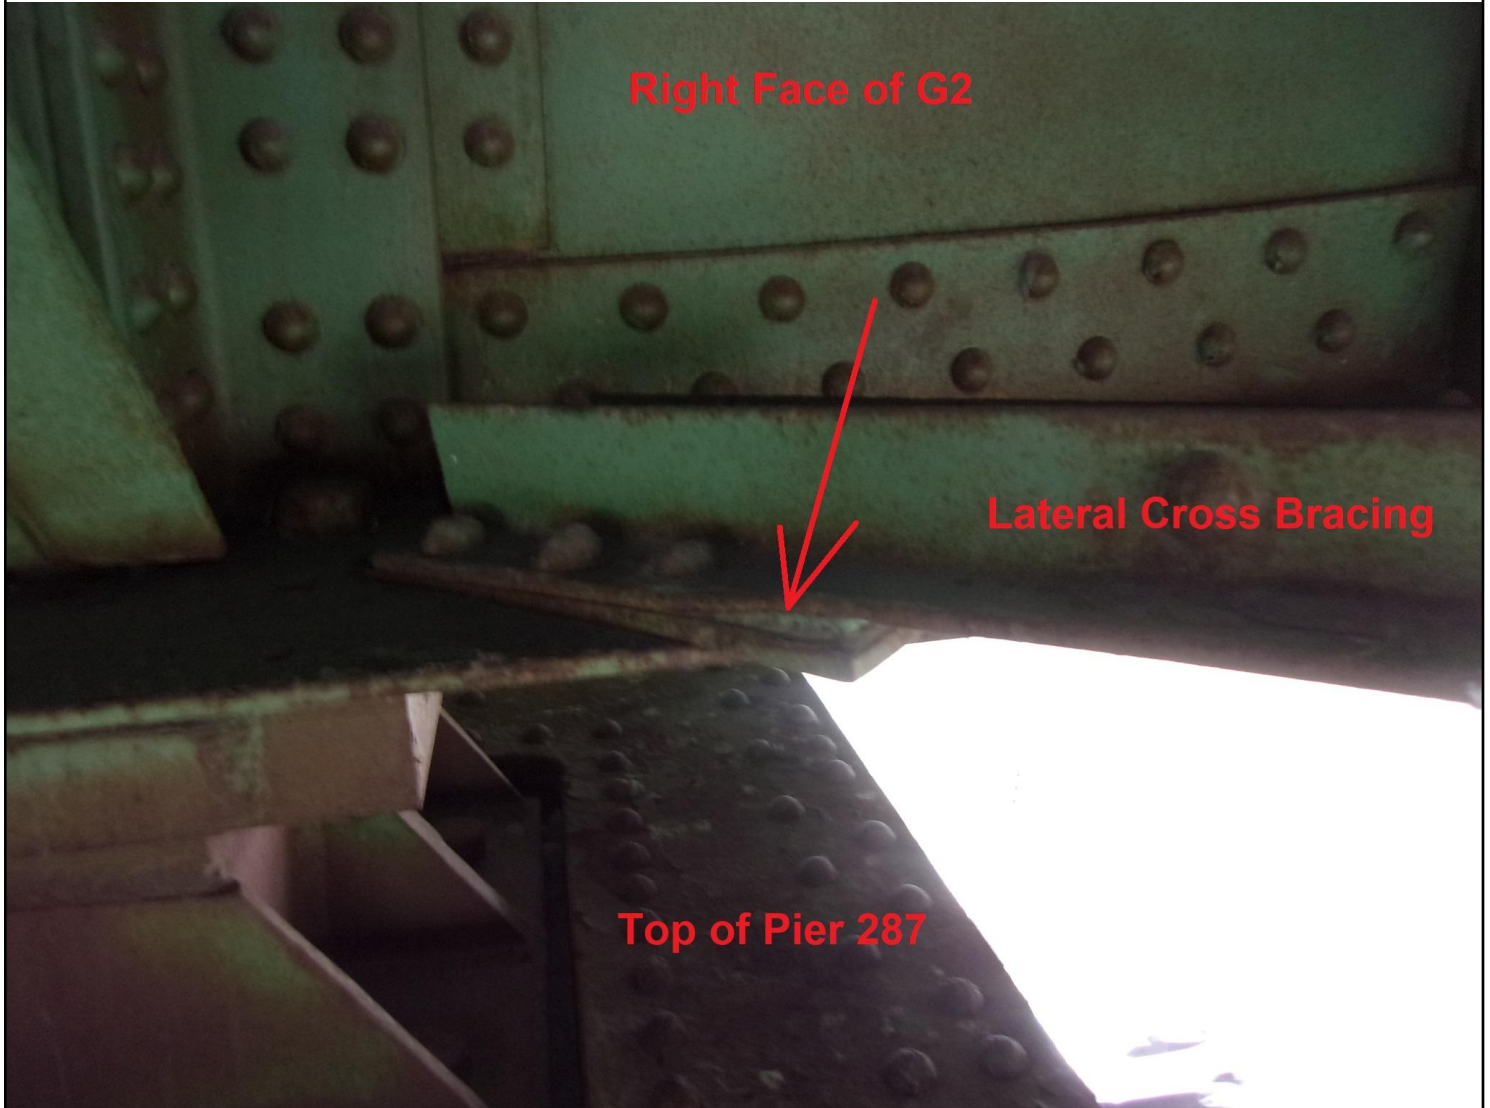
Photo Number: 4

**Attachment Description:** The right side of Girder G2 in Span 288 at Pier 287. The lateral bracing connection at the girder exhibits 1/2" pack rust. Looking Left.

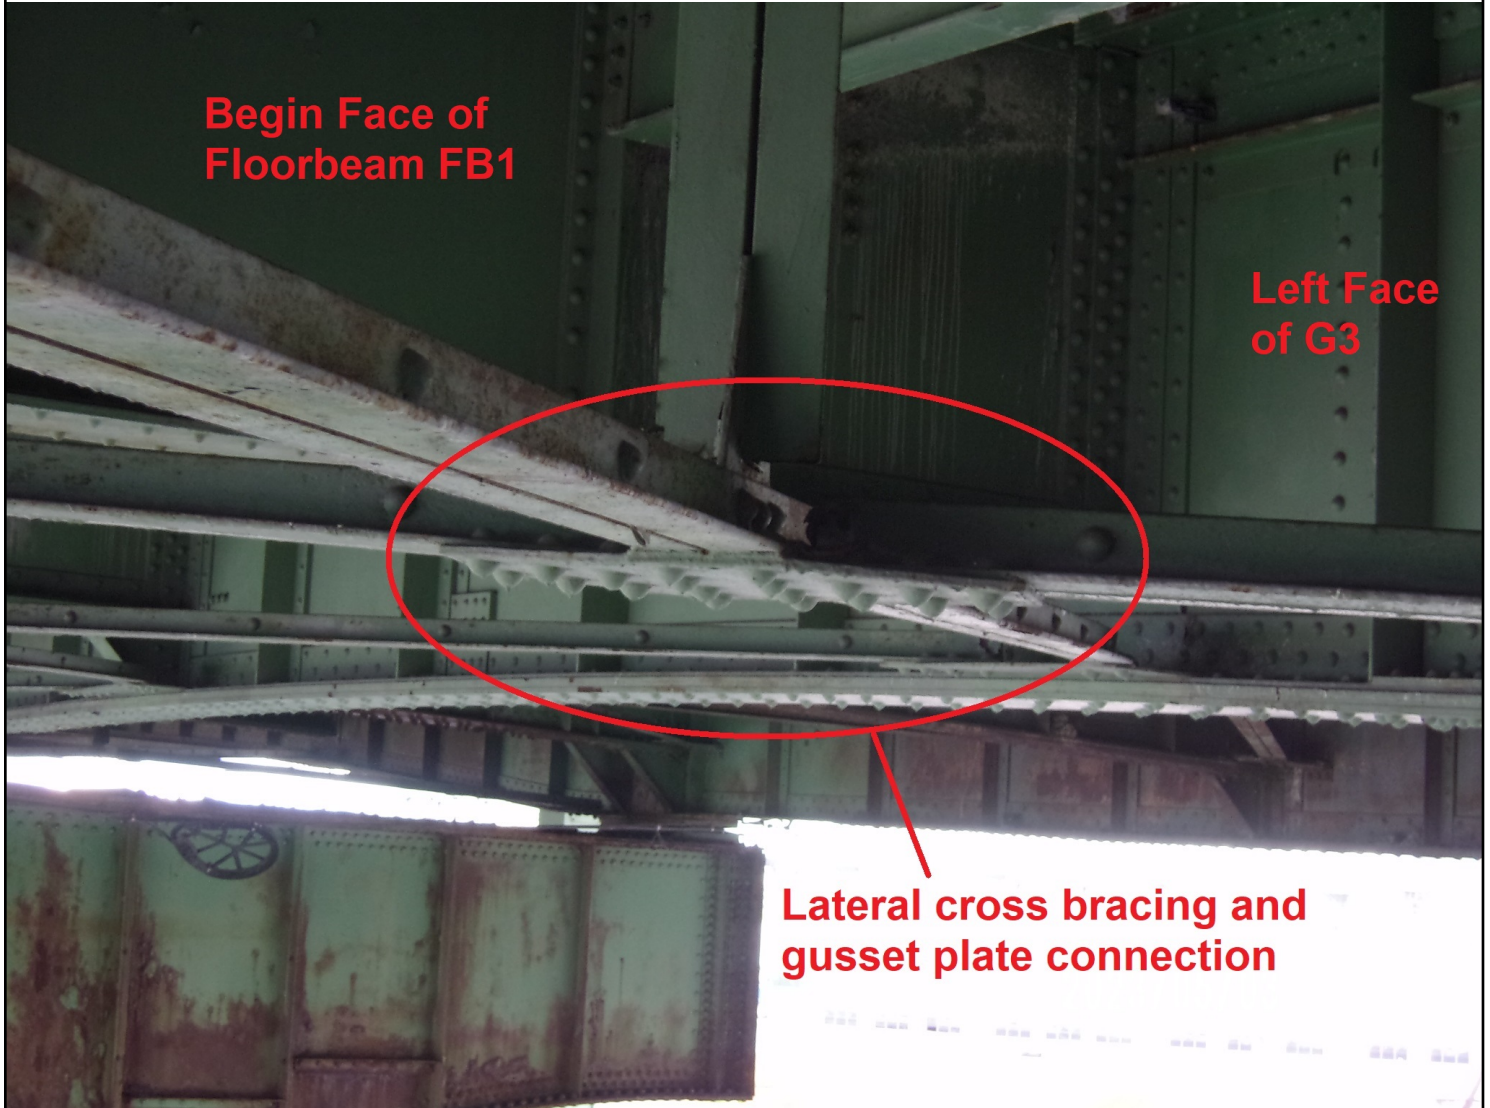
Photo Number: 5

**Attachment Description:** The gusset plate at the middle of the cross bracing between Girders G2-G3 and between Pier 287 and Floorbeam FB1 in Span 288. The lateral bracing connection at the gusset plate is in generally good condition (circled). Looking End and Right.

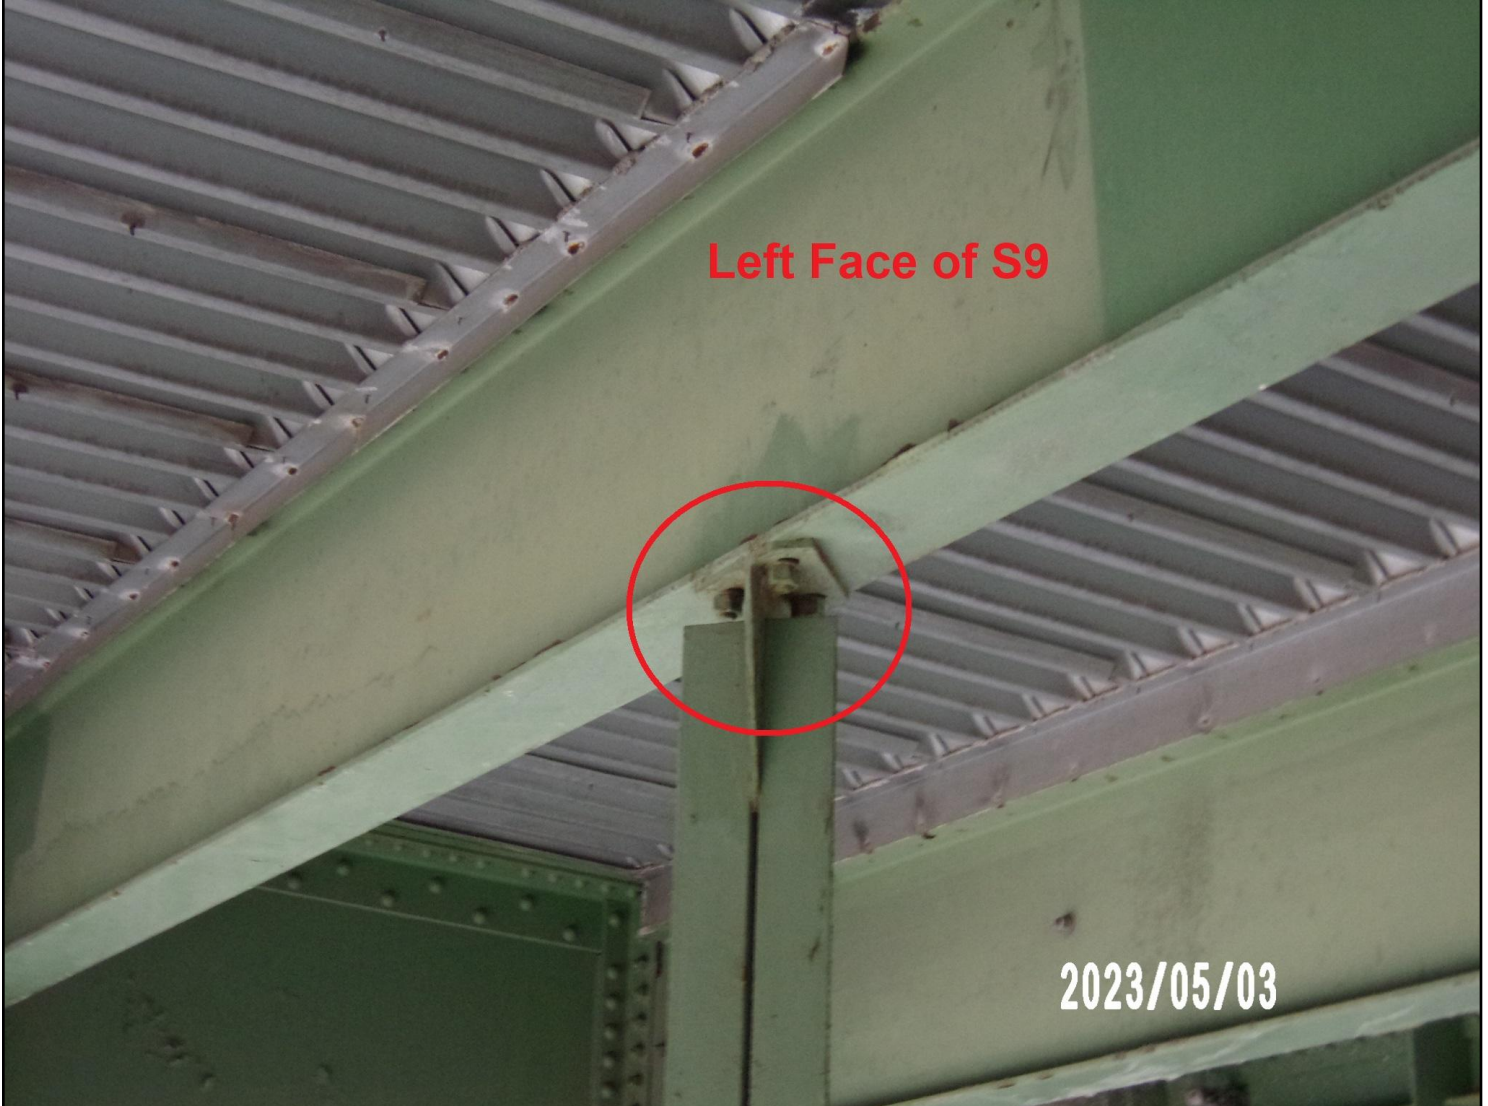
Photo Number: 6

**Attachment Description:** The midspan of Stringer S9 between Pier 287 and Floorbeam FB1 in Span 288. The lateral bracing connection at the bottom of the stringer is in generally good condition. Looking End and Right.
